#### **Presentation Outline**

# Drainage Lines and Structural Integrity of Retaining Walls (Structures)

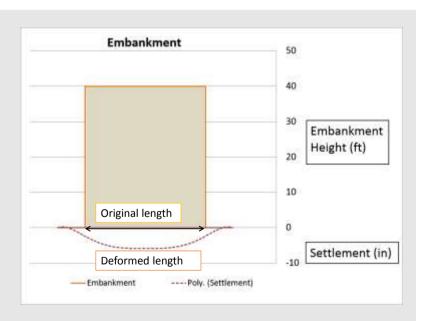
# Pipe Elongation

Elongation due to settlement for the 40' tall sample embankment < 1"

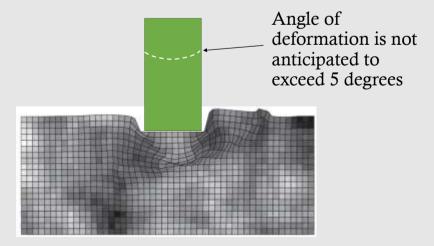
# **Pipe Deformation**

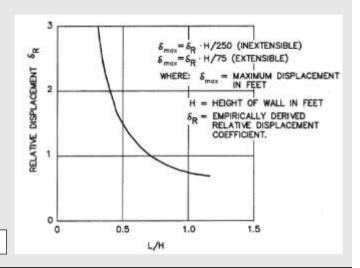
## **Lateral Displacement**

- AASHTO C11.10.4.2
  - A first order estimate of lateral wall displacements on firm foundations
  - If significant vertical settlement is anticipated lateral displacements could be considerably greater.

For example: [(1)(40')(12)]/75 = 6.4"
